Windows

Rehabilitation Standard No. 6 - Part 1

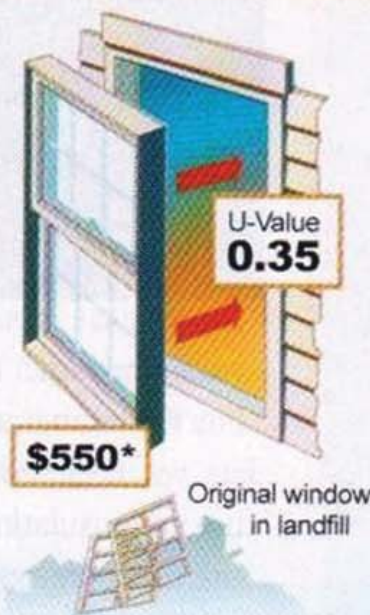
Low-e glass double-pane thermal replacement of single-pane window

902,772 Btu

\$16.10

**34
Years**

$\$550/\$16.10 =$

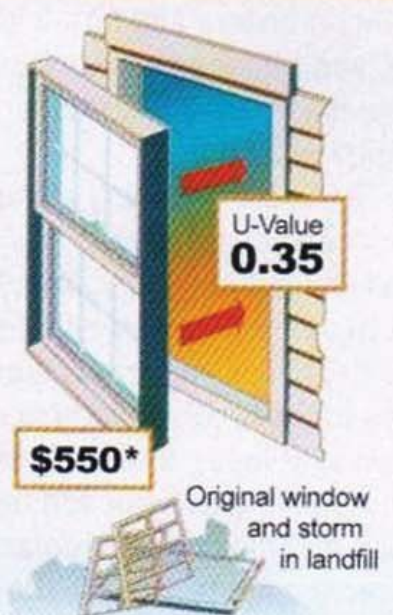
Low-e glass double-pane thermal replacement of single-pane window with storm window

132,407 Btu

\$2.29

**240
Years**

$\$550/\$2.29 =$

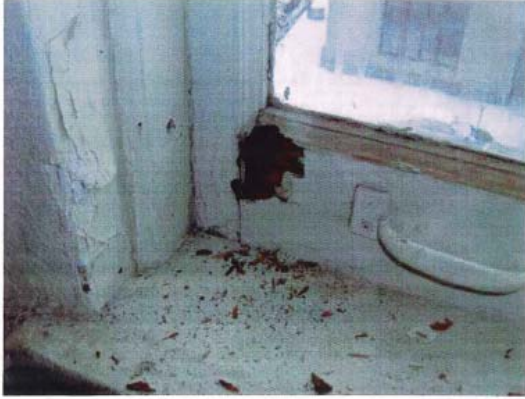
FOURTH FLOOR

Window 410: Bottom sash, bottom rail has significant rot at the attachment point of the left hand stile. The joint is not loose however; this may stay as a class II for condition. However there will be a significant amount of labor to do so. See photographs for 410 below.

WINDOW 410:	CONDITION	PAINT
Top Sash Top Rail	Class II	Class III
Top Sash LH Stile	Class II	Class III
Top Sash RH Stile	Class II	Class III
Top Sash Check Rail	Class II	Class III
Bottom Sash Bottom Rail	Class III	Class III
Bottom Sash LH Stile	Class II	Class III
Bottom Sash RH Stile	Class II	Class III
Bottom Sash Check rail	Class I	Class I
Sill	Class II	Class III
LH Jamb	Class I	Class II
LH Brickmold	Class II	Class III
RH Jamb	Class I	Class II
RH Brickmold	Class II	Class III
Head Jamb	Class I	Class I
Head Brickmold	Class II	Class III
Glass	ONE BROKEN	
Muntins	Class I	Class II
Glazing	Class I

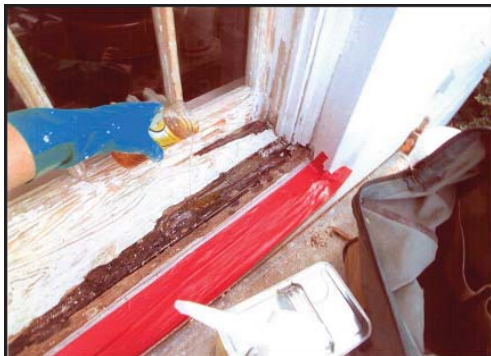
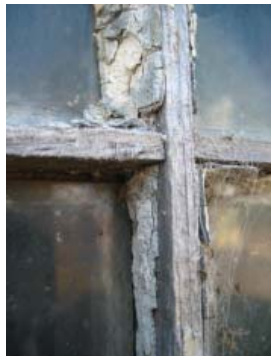
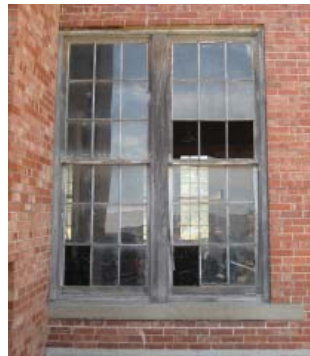
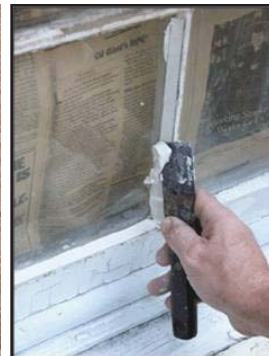
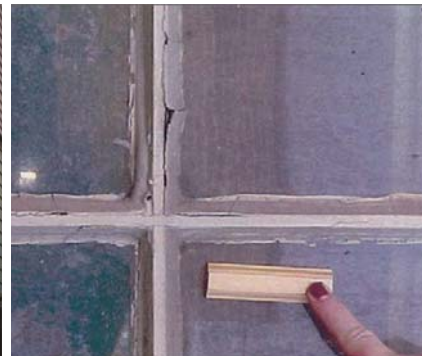
Common Window Problems and Repair Solutions

Problem	Likely Cause	Solution
Flaking / missing paint	Deterioration from weather, or may indicate excess moisture levels in wood.	Check moisture levels in wood and correct any moisture problems. Remove loose paint to sound paint layer or wood, prime and repaint.
Damp plaster around interior side of window	Lack of ventilation, or water leaking in around window frame.	Check for water penetration around exterior window frame and caulk where necessary. Serious water leakage will require more investigation. Remove defective plaster and ensure all adjacent areas are dry before replacing plaster.
Broken / cracked glass	Accidental damage or vandalism. Small diagonal cracks in corners indicate distortion in sash frame.	Small corner cracks in original, valuable glass are often acceptable. For large breaks, remove broken glass without damaging wood framing and re-glaze. (See Missing / cracked glazing putty)

Broken sash cords	Wear and tear in old cords or cord snagging on pulley wheel.	Take out sashes and weigh them to ensure correct weight. Replace or add weight as necessary. Replace sash cord (cotton rope is best, nylon rope will break down from UV light). Keep cord free of paint. Check that sash pulleys move freely and won't snag cord.
Missing / cracked glazing putty	Deterioration from ageing or where new putty has not been re-painted correctly.	Cut out defective putty. Putty may first need to be softened by an alkali paint stripper, or, with extreme care to not crack glass, a heat gun on low setting. Coat exposed muntins with boiled linseed oil before applying new putty. UGL GLAZOL® putty is acceptable, DAP® putty is not recommended. Wait 28 days before priming and painting putty.
Wood decay in sill	Water pooling from improper slope of sill away from window.	Remove all decayed wood to repair with an epoxy like Abatron®, or replace with new matching wood. Ensure sill slopes down away from window for proper drainage. You may also cut a drip line on the underside of the sill. Prime and repaint.

Wood decay in sash joinery (commonly at lower rails and mortice joints of upper and lower sashes)	External weathering or excessive internal condensation on horizontal frame members.	Remove all decayed wood to repair with an epoxy like Abatron®, or replace severely deteriorated pieces with splices of new matching wood. If muntins need repair it is best to replace the whole piece, unless it is minimal deterioration / damage. Prime and repaint.
Sash joints opening up	Mortices snapped or dowels cracked.	Glue, wedge and clamp the joint. Or strengthen sash by adding non-ferrous metal angle plates across corners. You may also piece in new wood pieces at rails and stiles with new mortices and/or tenons. Any old, loose dowels should be carefully driven out and new dowels glued into place. Prime and repaint as necessary.

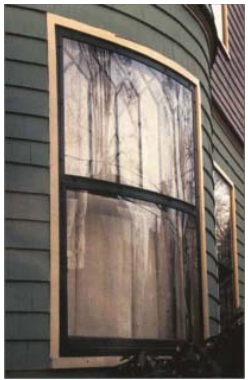
Storm windows can be installed on the interior or exterior of historic windows and can be made out of materials like wood and aluminum, among others.

Exterior storms protect the more valuable prime window, but can also obscure the historic window if not done properly. **Interior storms** leave the historic, prime window unprotected and may allow it to deteriorate faster, however they do not obscure the historic window.

Leaded glass windows require extra attention when adding interior or exterior storms. Exterior storm windows will create a greenhouse effect that can melt the lead and cause the window to buckle. Interior storm windows will cause condensation to gather on the prime window that can exacerbate rot or rust on the prime window. In either case, it is important to vent the outermost window (prime or storm) to prevent this.
